Riser Repair – Structural and Pressure Containing

A 500mm NB gas riser on an offshore platform had experienced significant wall thinning due to external corrosion below the platform sea deck. A Technowrap™ solution was provided which met the required standards of ASME B31.8 (gas transmission and distribution, as an AEA class 3 pipe repair) and ISO 24817 with structural loadings for axial and bending moment. The repair documentation included drawings, work method statement, detailed design and the typical ICR.IAS JV quality documentation.

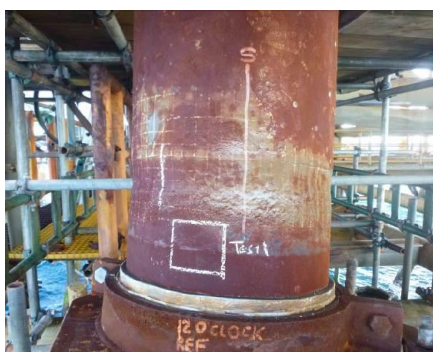
Corrosion location on Riser

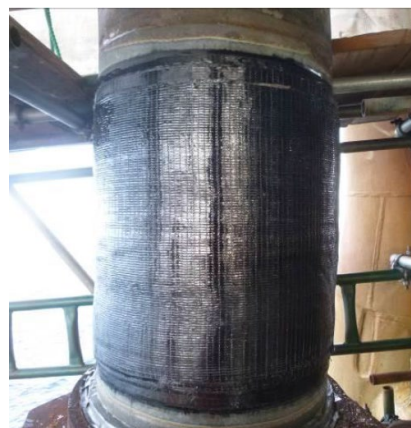
Technowrap™ repair partially completed

- Combination of Technowrap™ fibres to deliver the structural requirements and minimise material and labour costs
- Technowrap 2K™ LT system used to wrap all fibre types

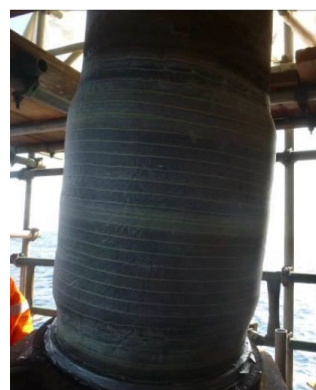
Completed Technowrap™ repair with 2k fibre final coating
