Live Leak Full Encapsulation Repair

IC Integrity was engaged to provide a live leak repair over a severely corroded flange, clamp, elbow and cold chiller line. IC Integrity site team provided a turnkey solution for the client to meet a rapid turn around requirements and manage risks which included the line breaking off due to being so thin from wall loss. There were large sections which were not surface prepared and had pre-cured Technowrap sections applied initially to strengthen the line before the full wrap repair was applied.

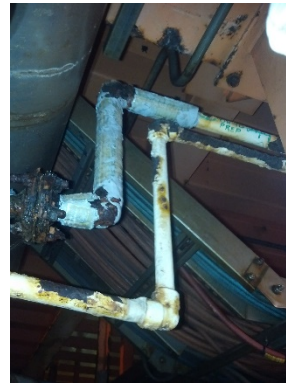
Extreme corrosion prior to Technowrap solution

- Technowrap 2K™ HA system with temperature resistance up to 100°C.
- Complex geometry application according to ISO 24817 and designed for full structural loads.
- Staged approach to manage the risks associated with existing leaks and the potential for the line to break (very thin wall).
- A range of resin systems used to manage sweating pipe, live leak sealing and pre-formed pipe sections.
- Detailed engineering and risk assessment completed in-house as part of the planning and work pack development.

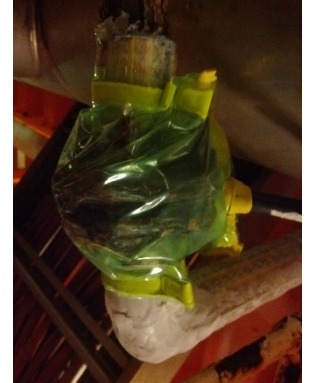
Structural half shells

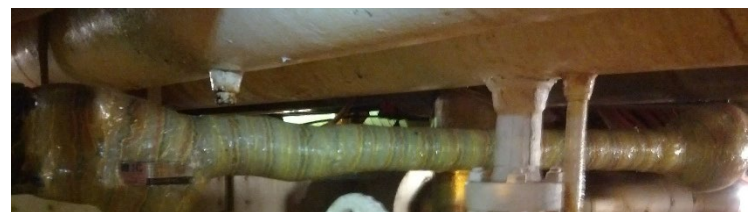
Completed Repair
